UNIVERSITY SURVEY & ADA EVALUATION

Priority 1 - Parking

Bldg Example 100

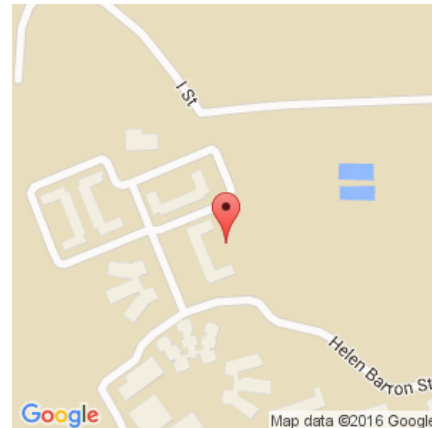
Overall status: Out of Compliance

Comments: Findings - The access space is 9 feet 2 inches and the access aisle is 60 inches or 5 feet.

Comments: Findings - The access space is 11 feet and the access aisle is 5 feet.

Value: The bottom of the sign is below 60 inches.

Comments: Findings - The signs range from 57 inches to 60 inches.

Recommendations - There could be more access space.

Value: The signs must be raised and I also recommend repainting the accessible parking spots.

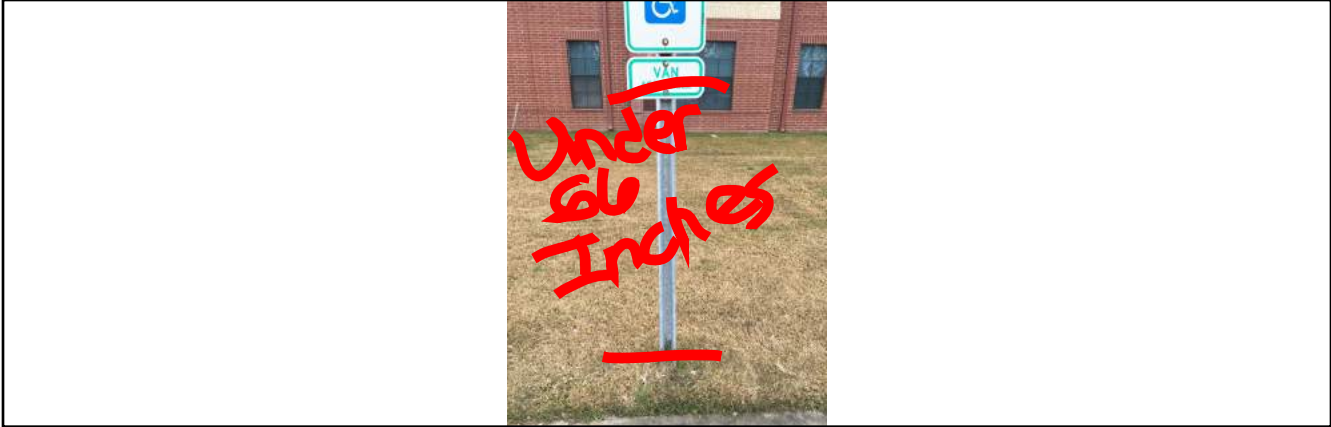
Status: Out of Compliance (NO)

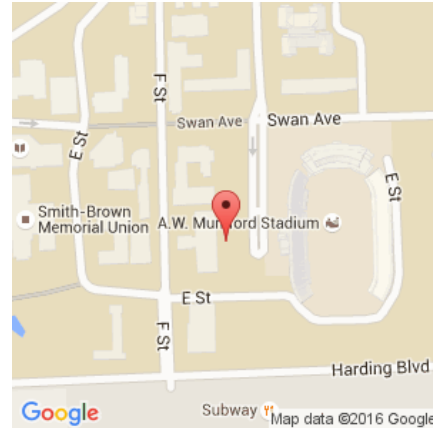
Value: This area is accessed by persons who live in the building and the public. However the parking area is 100% out of compliance with any parking requirements

Value: There is no accessible parking at the rear or west side of Reed Hall

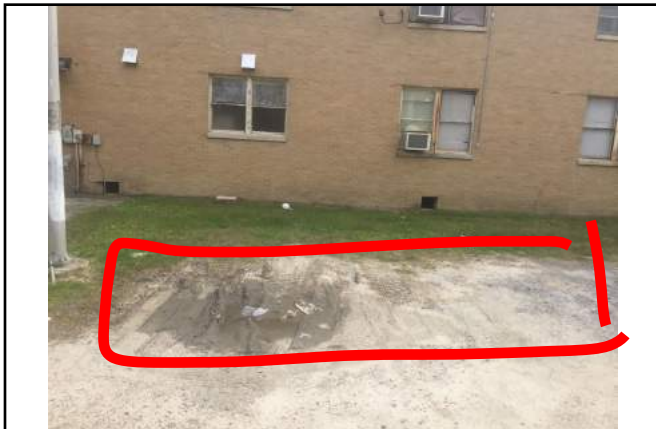
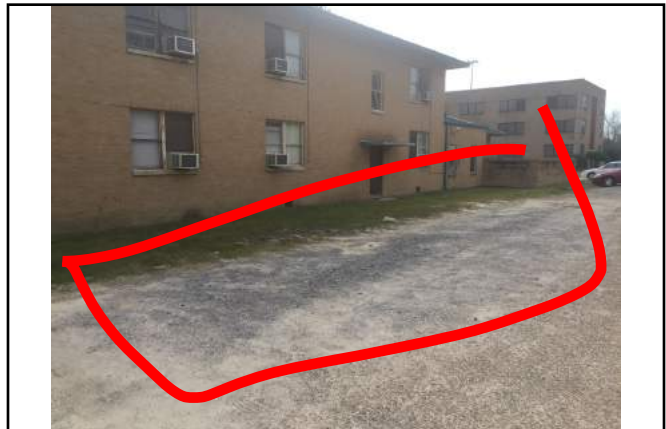
Status: Out of Compliance (NO)

Value: Such as resurfacing the parking area and placing the appropriate signs. Or, put up sign stating no parking.

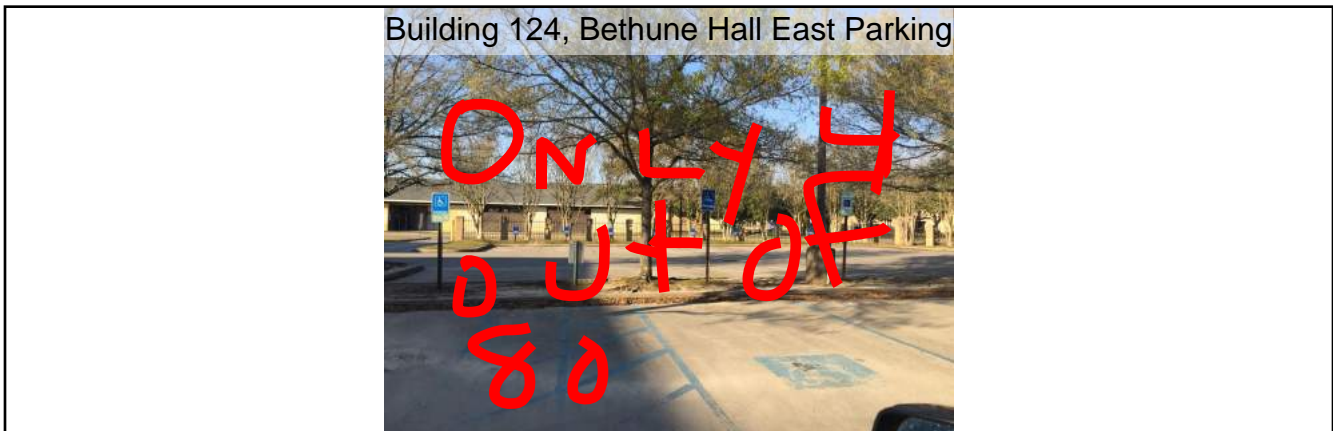
Status: Out of Compliance (NO)

Value: No

Comments: There are only four out of 80 parking spaces that are for the handicapped.

Value: More handicapped parking spaces are needed. Accessible lanes to the building should be provided. Access ramp to the building needs to be better marked, and it should include visual ridges feel ridges for the visually impaired

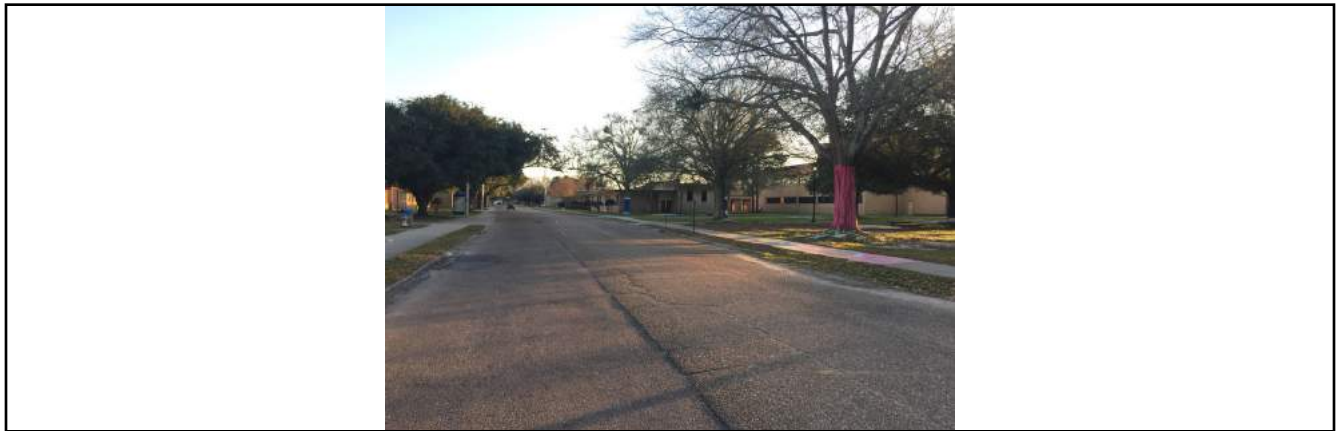
Status: Out of Compliance (NO)

Value: 2 spaces provided

Value: University should really invest in striping. University should we invest in resurfacing.

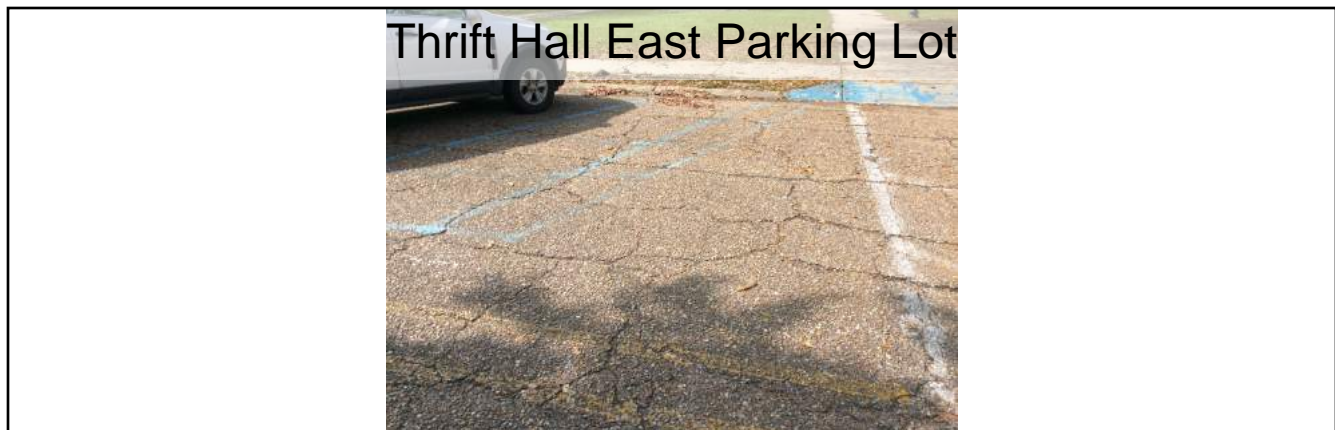
Status: Out of Compliance (NO)

Value: Aisles are marked but not clearly visible

Recommend marking clear Isles from handicap parking to curb approach

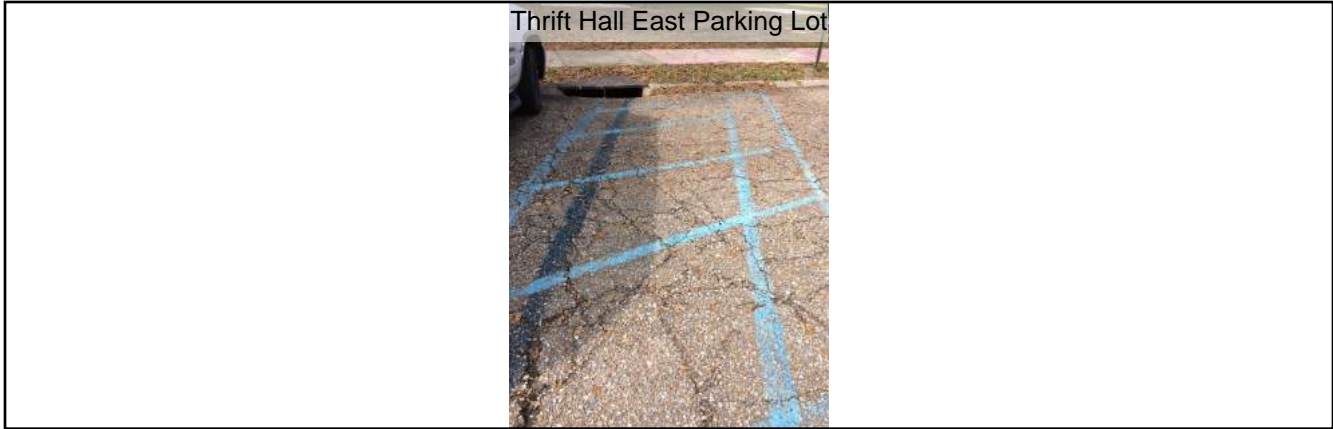
Status: Out of Compliance (NO)

Value: Not all access aisles adjoin an accessible route

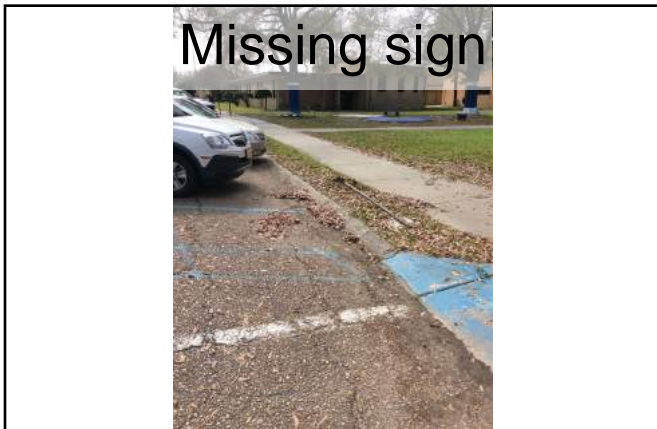
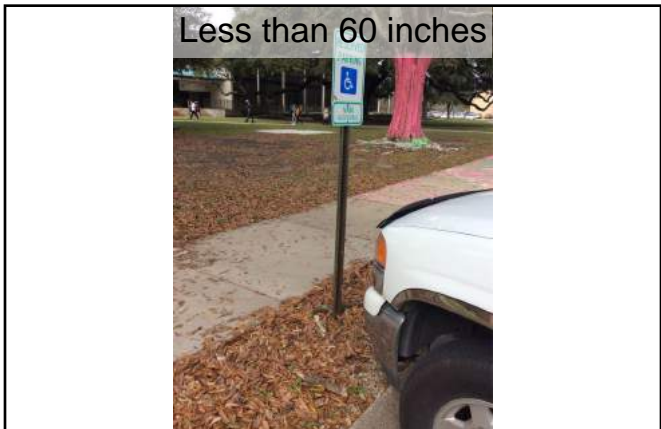
Status: Out of Compliance (NO)

Value: Signs are not required height
