UNIVERSITY SURVEY & ADA EVALUATION

Priority 1 - Parking

Bldg Example 100

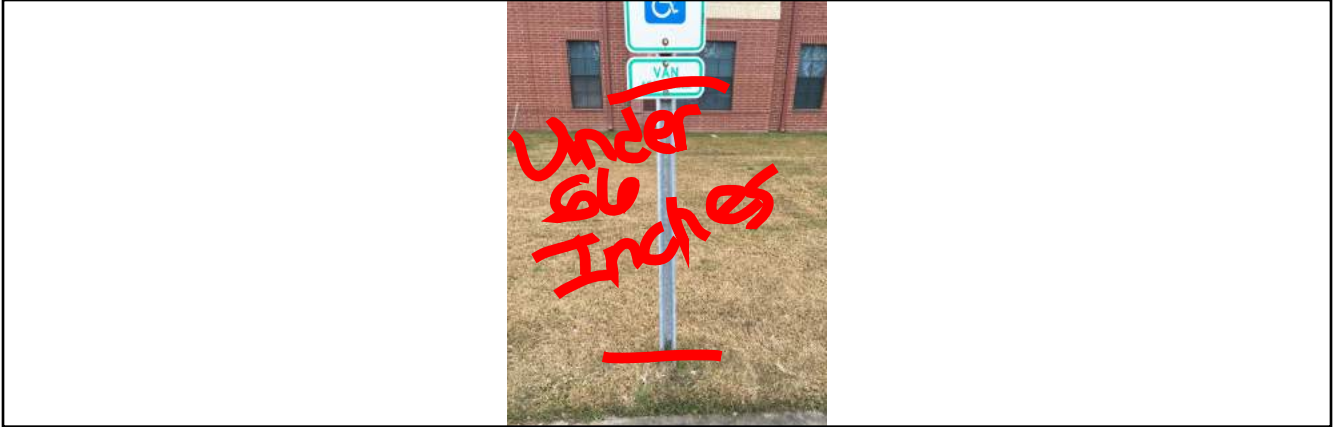
Section 1.10 502.6 Identification

Are accessible spaces identified with a sign that includes the International Symbol of Accessibility? Is the bottom of the sign at least 60 inches the ground?

Status: Out of Compliance (NO)

Value: The bottom of the sign is below 60 inches.

Comments: Findings - The signs range from 57 inches to 60 inches.

Value: The signs must be raised and I also recommend repainting the accessible parking spots.

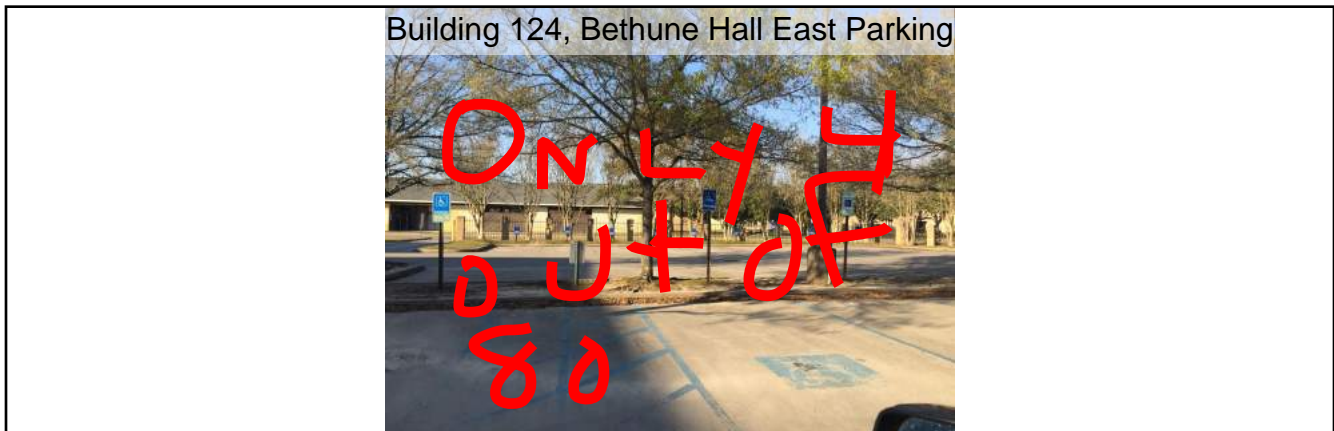
Section 1.2 Codes 502 parking spaces and 208.2 Minimum number

If parking is provided for the public, are an adequate number of accessible spaces provided?

Status: Out of Compliance (NO)

Value: No

Comments: There are only four out of 80 parking spaces that are for the handicapped.

Value: More handicapped parking spaces are needed. Accessible lanes to the building should be provided. Access ramp to the building needs to be better marked, and it should include visual ridges feel ridges for the visually impaired

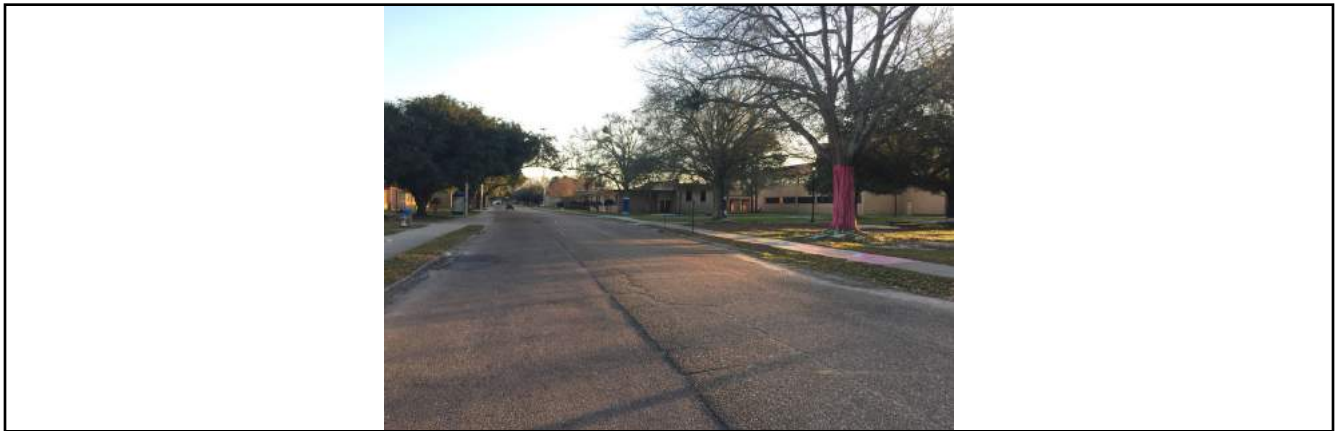
Section 1.2 Codes 502 parking spaces and 208.2 Minimum number

If parking is provided for the public, are an adequate number of accessible spaces provided?

Status: Out of Compliance (NO)

Value: 2 spaces provided

Value: University should really invest in striping. University should we invest in resurfacing.

Recommend marking clear Isles from handicap parking to curb approach

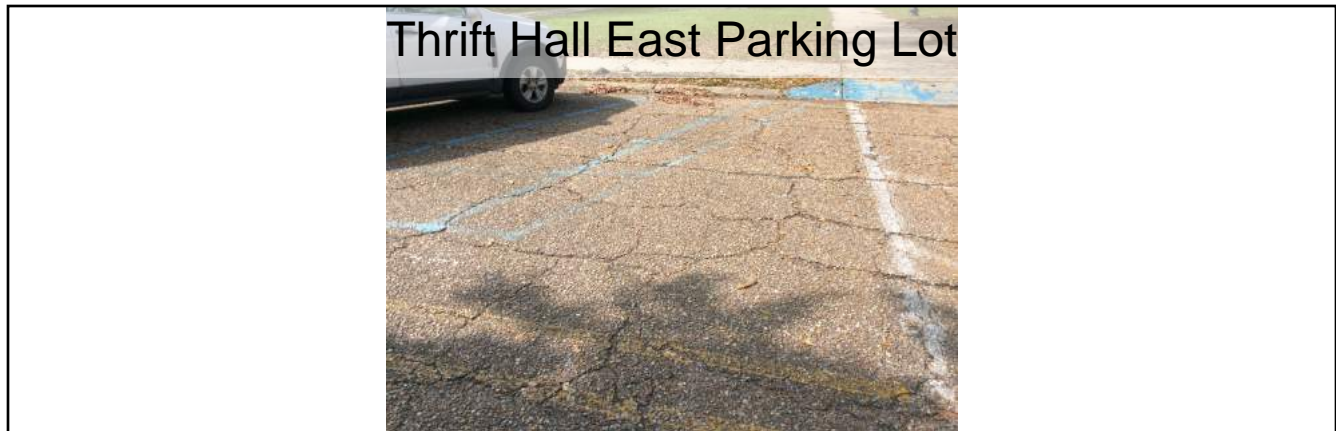
Section 1.7 Codes 502.3.3 Marking

Are the access aisles marked so as to discourage parking them?

Status: Out of Compliance (NO)

Value: Aisles are marked but not clearly visible
